Rescuing a Manufactured-Stone Wall

A properly flashed water-resistant drainage plane is essential when installing stone veneer over a wood-framed wall

by Mark Parlee

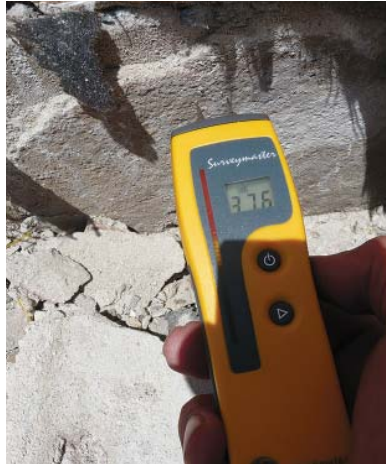
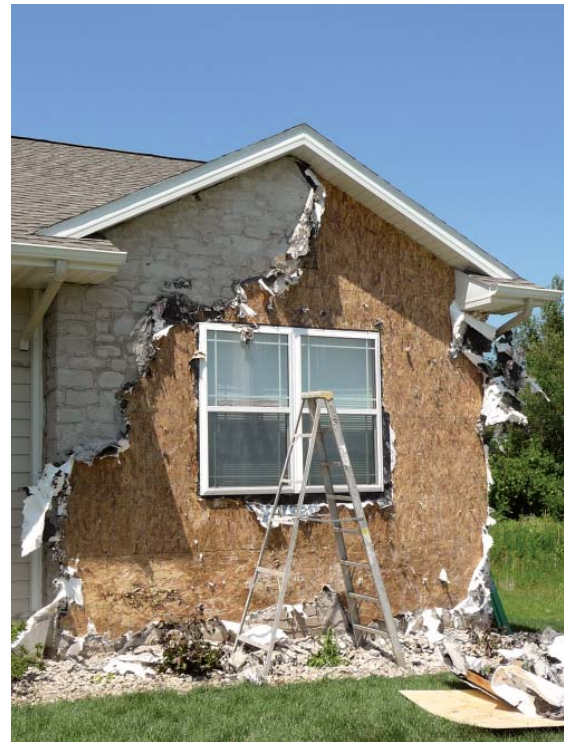
After most of the stone veneer and mortar base coat had been removed and the OSB sheathing exposed, moisture readings confirmed my suspicions: Water was getting behind the cladding and migrating into the wall system — not just around the double window, but everywhere (see Figure 1).

Although the problem was clearly worst around the window, there were elevated moisture levels at the corners of the facade and above the window, as well as in the stone veneer remaining on the wall. Below the window and at the base of the wall, moisture content readings in the wall sheathing exceeded 90 percent.

Figure 1. Though it looked sound from the outside, the manufactured-stone veneer on this nine-month-old house was absorbing water and soaking the mortar base coat (left) and the sheathing and framing underneath. The only way to fix the problem was to pull off the stone (right) and install a proper substrate.

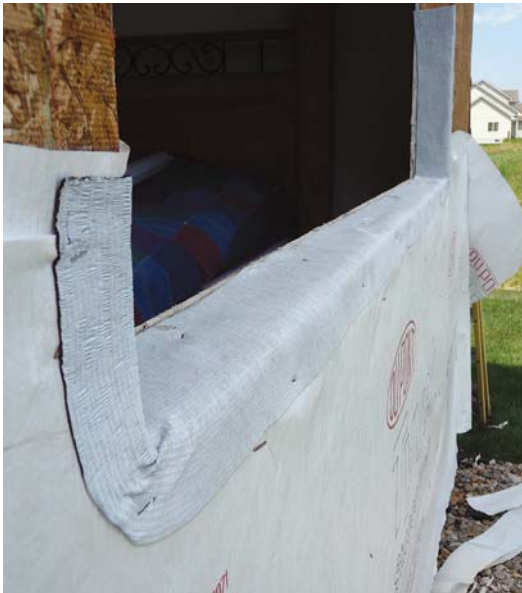
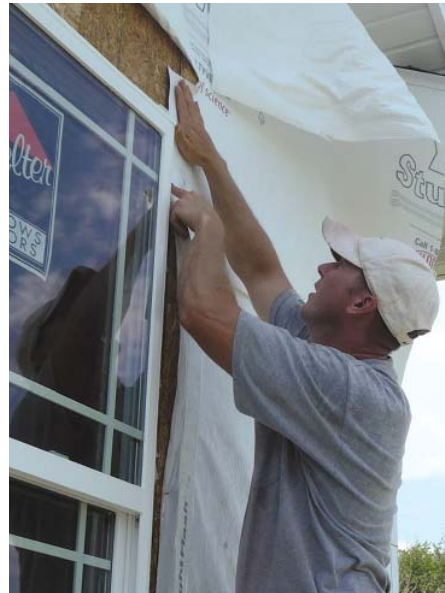
Figure 2. A sill pan fashioned from FlexWrap (far left), installed on top of the StuccoWrap, protects the rough window opening. The window is reinstalled with the nailing flanges set in sealant, then taped to the StuccoWrap (left).

Since most of the leakage occurred around the window opening, we were careful to detail the WRB and flashing properly when we reinstalled the window in the wall (Figure 2, page 2). We used DuPont FlexWrap, a flexible flashing tape, to create a sill pan at the bottom of

the opening. Then we reset the window in a bed of sealant at the nailing flange, finished wrapping the wall with StuccoWrap, and sealed the window nailing flanges to the wrap with StraightFlash self-adhering flashing tape.

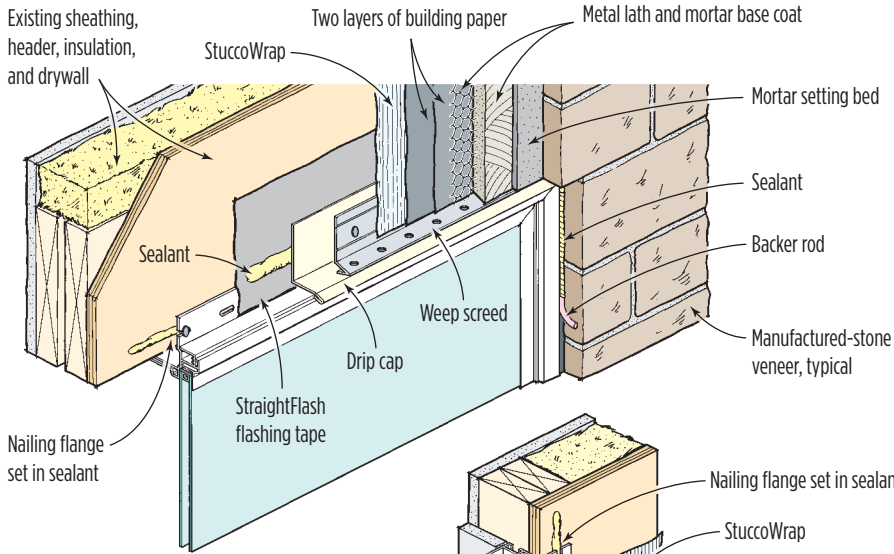
Window Head

A double layer of building paper installed over StuccoWrap creates a drainage plane beneath the mortar base coat. Galvanized metal weep screeds at the top of the window and at the base of the wall allow water to drain out of the assembly.

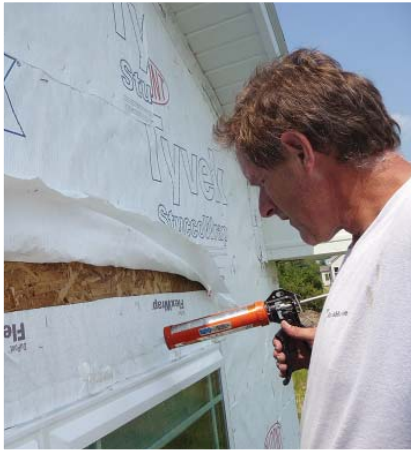
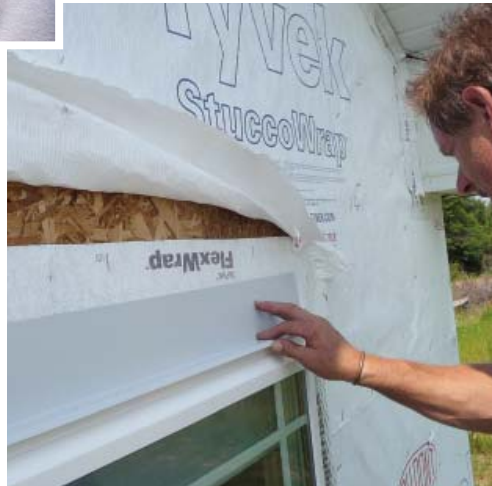
Figure 3. To limit water and air infiltration, the author applies a bed of sealant to the flashing tape above the window (above), then installs the metal cap flashing (right).

It's important that the flashings used with manufactured-stone veneer are wide enough to divert water out and over the stone. The head flashing over this window was custom-fabricated from 24-gauge G90 galvanized sheet metal with a painted finish (800/231-8127, berridge.com). We pulled back the StuccoWrap, applied a bedding sealant, and fastened the drip cap in place (Figure 3, page 4).

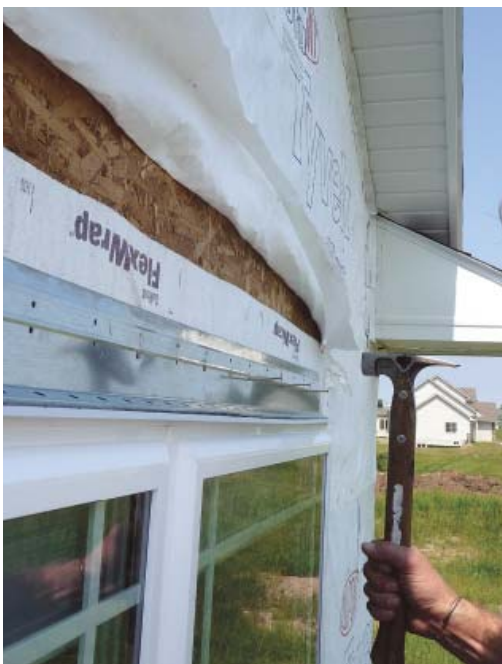
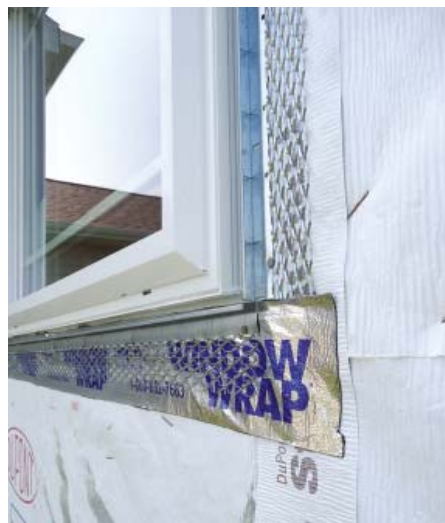
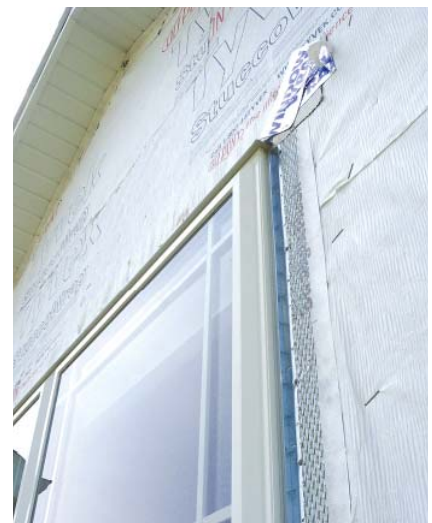
Figure 4. A metal weep screed above the window allows water to drain out from behind the cladding and mortar base coat (left). Metal J-mold is applied underneath the window (above left) and at the jambs (above right); flexible sealant is used to fill the joints between the J-mold and the window.

Before pulling the StuccoWrap back down, we attached a #36 weep screed over the drip cap (Figure 4, page 4). This screed is made from 26-gauge galvanized steel to meet FHA and code requirements for stucco installation (2006 IBC 2512.1.2).

It has a 3¹/₂-inch-wide flange and 1/2-inch-diameter holes in the kickout at the base, which help disperse water flowing down the drainage plane.

At the jambs and bottom of the window, we fastened stucco J-mold.

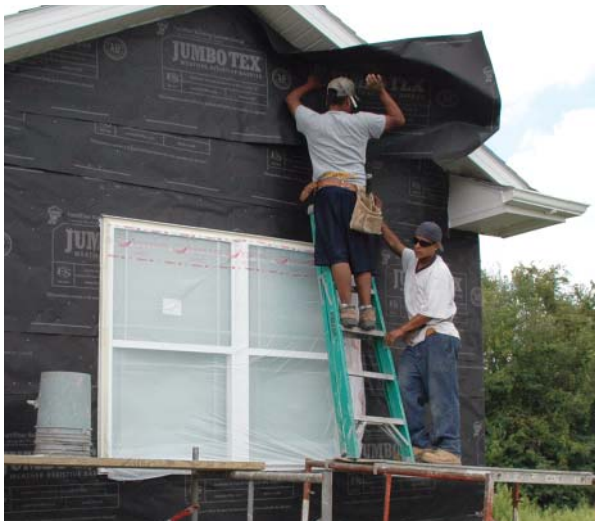
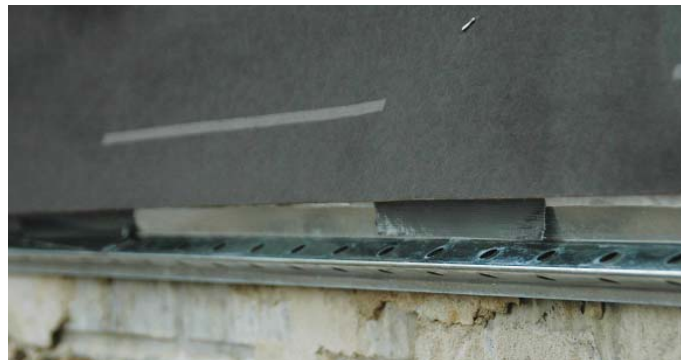
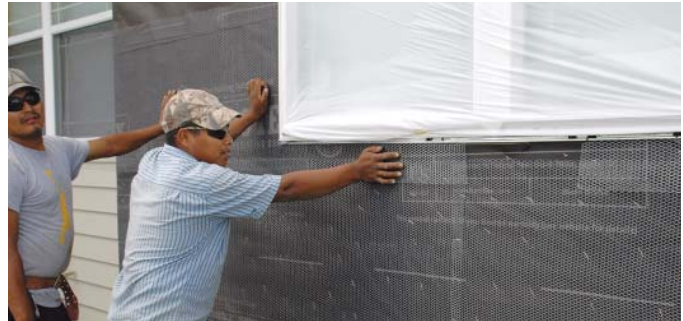
Figure 5. Crew members install a double layer of 60-minute grade D building paper on top of the StuccoWrap (above). The paper laps over a metal weep to allow for drainage at the base of the wall (above right). Galvanized metal lath (right) is then installed over the building paper.

Next we stapled up two layers of 60-minute building paper (Figure 5, page 5). At the base of the wall, we lapped the paper over #7 weep screed, which is similar to #36 screed except with a full V-profile at the ground. Then we installed the galvanized metal lath.

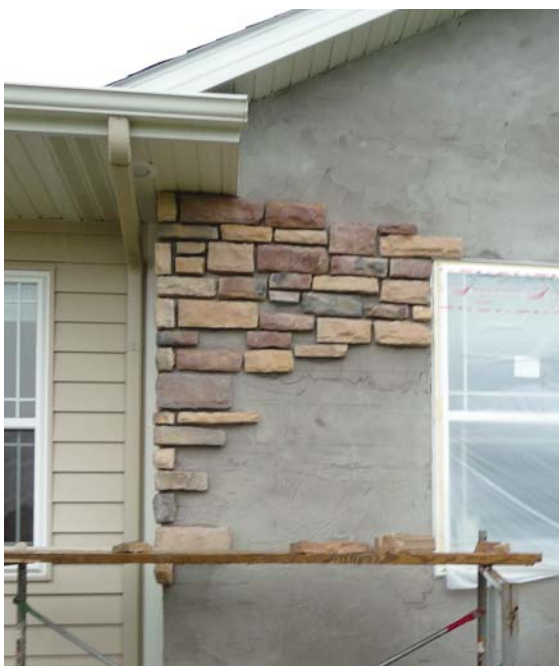
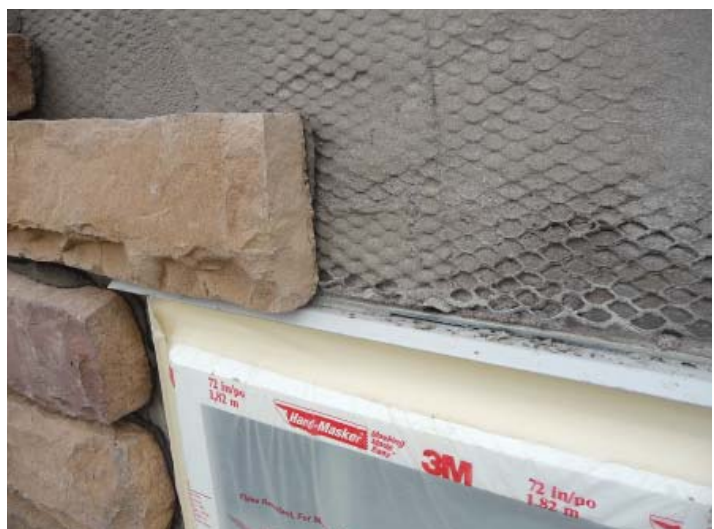
Figure 6. Like stucco, manufactured-stone veneer is applied over a base coat of mortar (left). The cap flashing (above) is sized to match the thickness of the stone veneer, to ensure that water is diverted to the surface.

After the masons applied the mortar base coat and finished reinstalling the stone veneer, we came back and detailed the joints between the window frame and the metal J-mold (Figure 6, page 5). To prevent three-point adhesion, we first filled the joint with backer rod, then applied

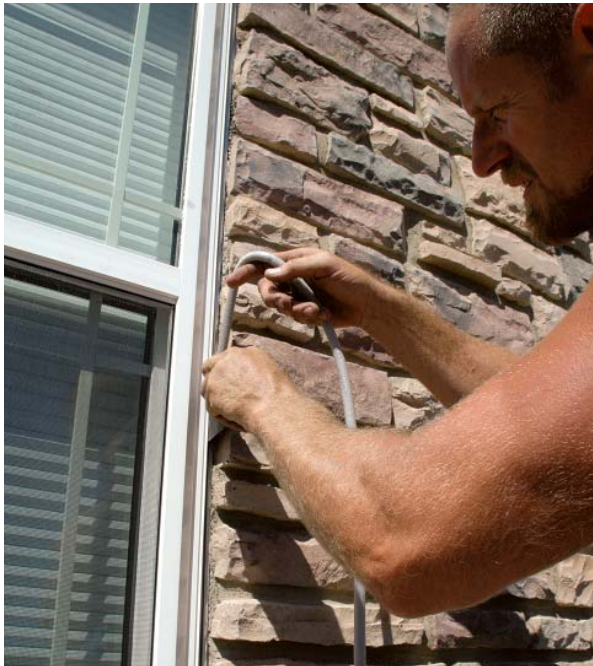
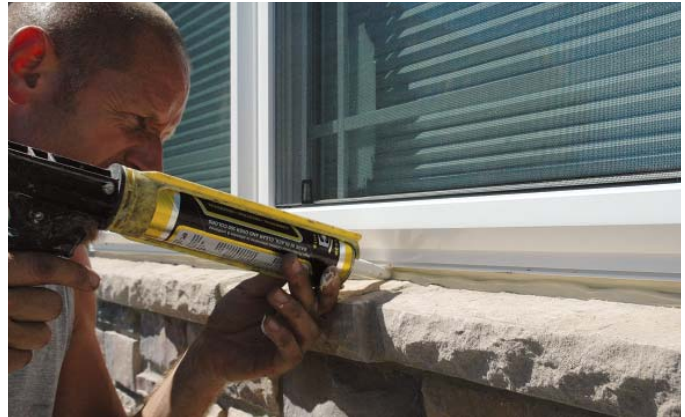
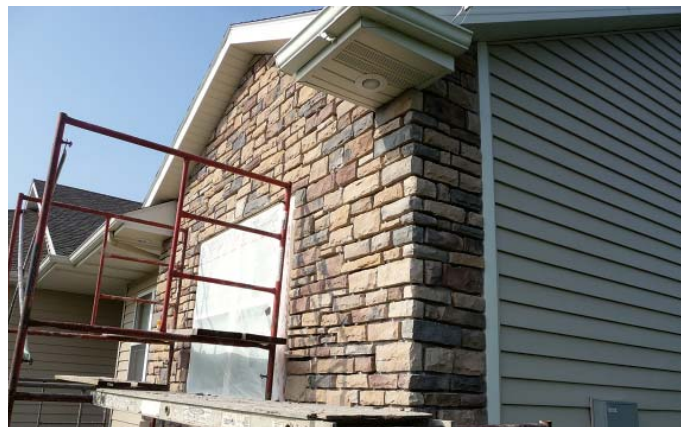
Figure 7. Backer rod inserted between the metal J-mold and the window frame (above) prevents the sealant used to fill the gap (above right) from adhering to the back of the joint, allowing it to remain flexible without pulling away from the sides. At right, the finished wall.

#900 Solar Seal adhesive sealant (800/654-1042, npcsealants.com), a solvent-based product that cures even when the mortar is still damp (Figure 7).
