Rescuing a Manufactured-Stone Wall

A properly flashed water-resistant drainage plane is essential when installing stone veneer over a wood-framed wall

by Mark Parlee

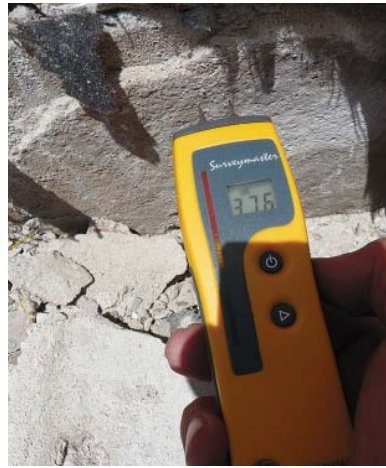
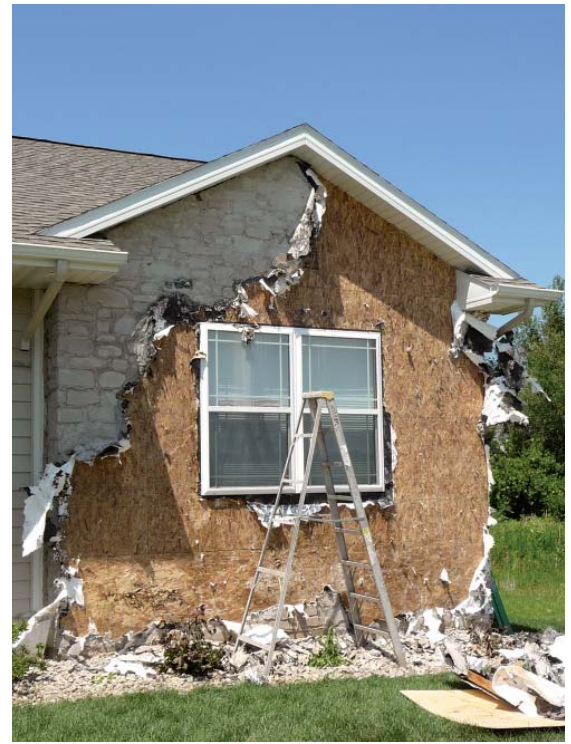
After most of the stone veneer and mortar base coat had been removed and the OSB sheathing exposed, moisture readings confirmed my suspicions: Water was getting behind the cladding and migrating into the wall system — not just around the double window, but everywhere (see Figure 1).

Although the problem was clearly worst around the window, there were elevated moisture levels at the corners of the facade and above the window, as well as in the stone veneer remaining on the wall. Below the window and at the base of the wall, moisture content readings in the wall sheathing exceeded 90 percent.

To look inside the wall cavity, we removed the window and opened up the wall from the outside in several places. We found that the bottom plate was saturated, with a lot of condensation on the plastic vapor barrier. Insulation pulled

Figure 1. Though it looked sound from the outside, the manufactured-stone veneer on this nine-month-old house was absorbing water and soaking the mortar base coat (left) and the sheathing and framing underneath. The only way to fix the problem was to pull off the stone (right) and install a proper substrate.

from the cavity under the window was wet on both its top and bottom edges, and water was clearly wicking up the studs. The smell of mildew was potent.

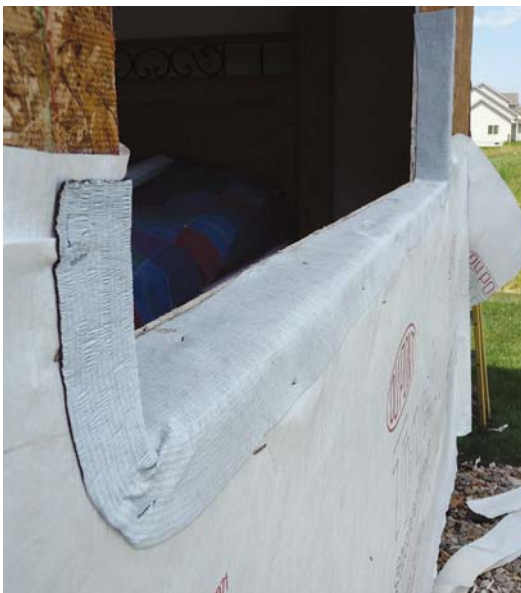
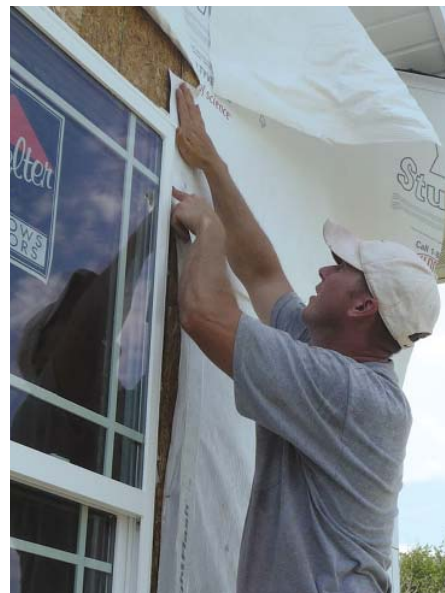
Figure 2. A sill pan fashioned from FlexWrap (far left), installed on top of the StuccoWrap, protects the rough window opening. The window is reinstalled with the nailing flanges set in sealant, then taped to the StuccoWrap (left).

Since most of the leakage occurred around the window opening, we were careful to detail the WRB and flashing properly when we reinstalled the window in the wall (Figure 2, page 2). We used DuPont FlexWrap, a flexible flashing tape, to create a sill pan at the bottom of

the opening. Then we reset the window in a bed of sealant at the nailing flange, finished wrapping the wall with StuccoWrap, and sealed the window nailing flanges to the wrap with StraightFlash self-adhering flashing tape.

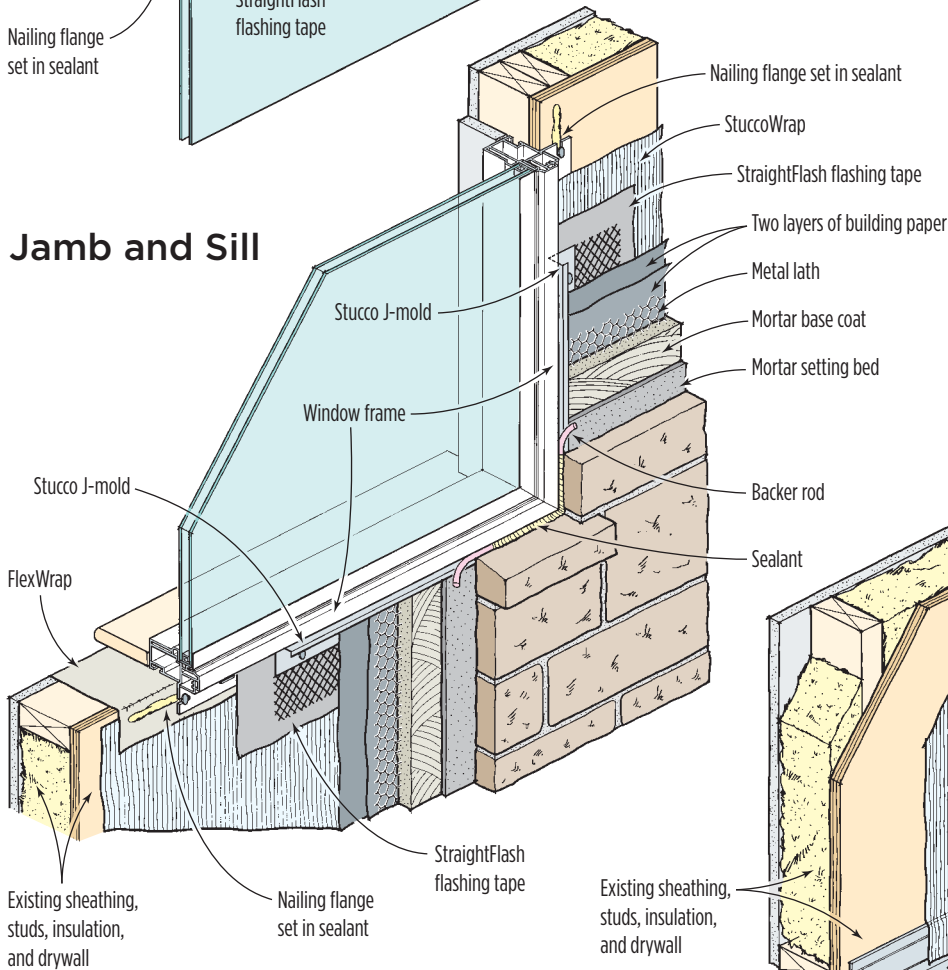
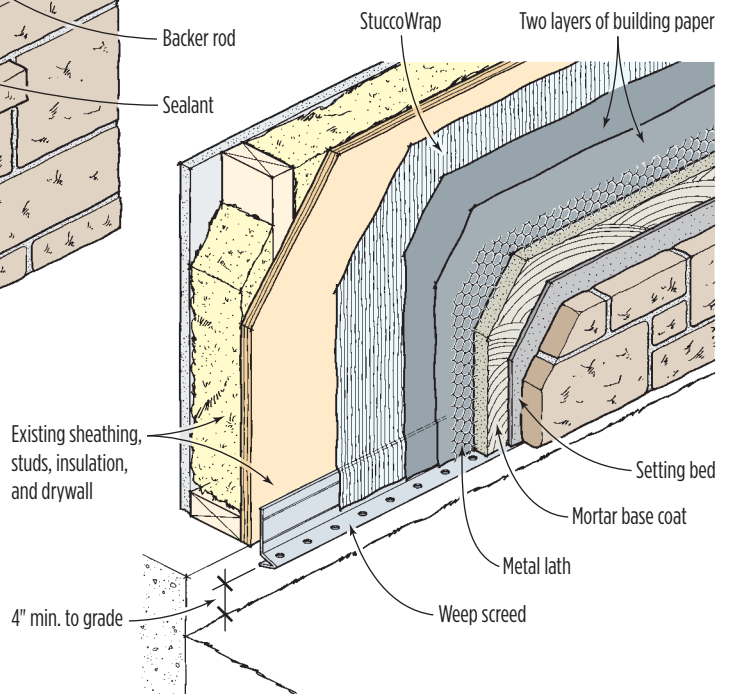
Substrate and Flashing Details

A double layer of building paper installed over StuccoWrap creates a drainage plane beneath the mortar base coat. Galvanized metal weep screeds at the top of the window and at the base of the wall allow water to drain out of the assembly.

Flashing Details” at culturedstone.com; click on Technical Info). But we upgraded the WRB to include a layer of DuPont Tyvek StuccoWrap (800/448-9835, www2.dupont.com) covered by two layers of Fortifiber Super Jumbo Tex 60-minute building paper (800/773-4777, fortifiber.com), a vapor-permeable asphalt-saturated kraft

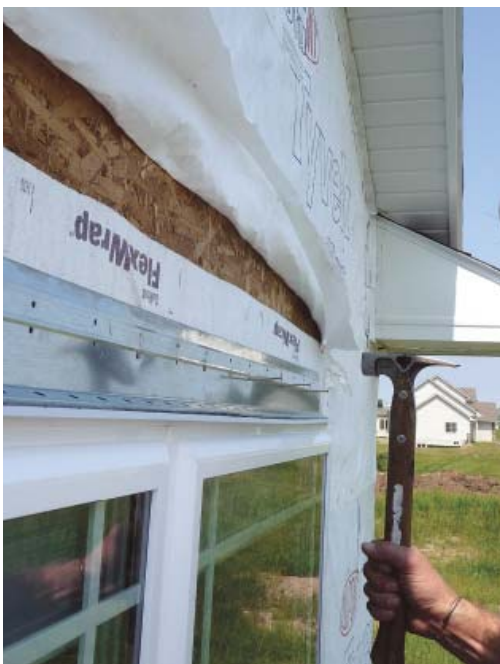
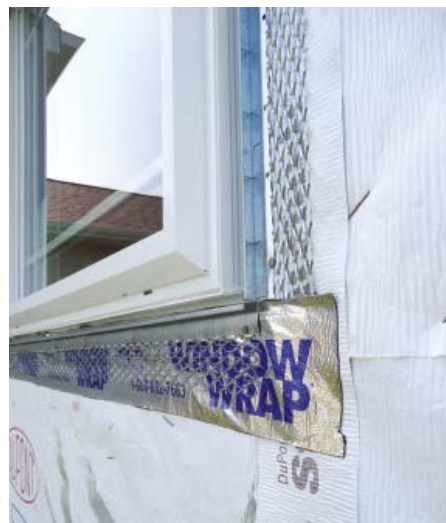
Figure 4. A metal weep screed above the window allows water to drain out from behind the cladding and mortar base coat (left). Metal J-mold is applied underneath the window (above left) and at the jambs (above right); flexible sealant is used to fill the joints between the J-mold and the window.

Before pulling the StuccoWrap back down, we attached a #36 weep screed over the drip cap (Figure 4, page 4). This screed is made from 26-gauge galvanized steel to meet FHA and code requirements for stucco installation (2006 IBC 2512.1.2).

It has a 3¹/₂-inch-wide flange and 1/2-inch-diameter holes in the kickout at the base, which help disperse water flowing down the drainage plane.

At the jambs and bottom of the window, we fastened stucco J-mold.

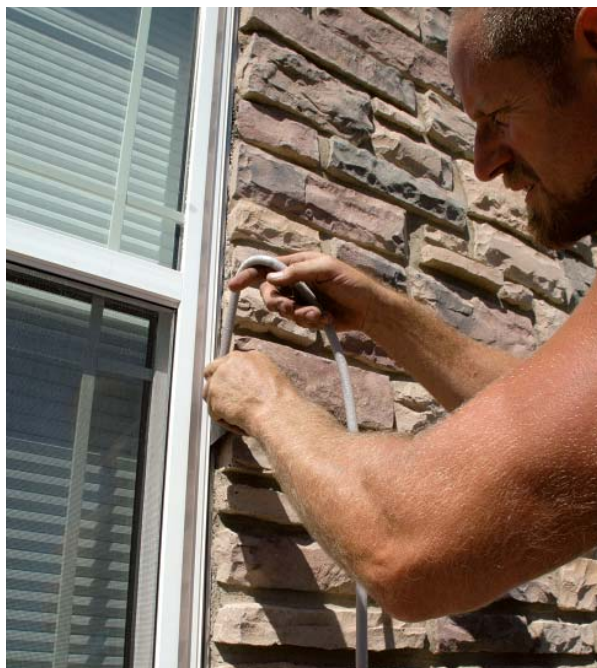
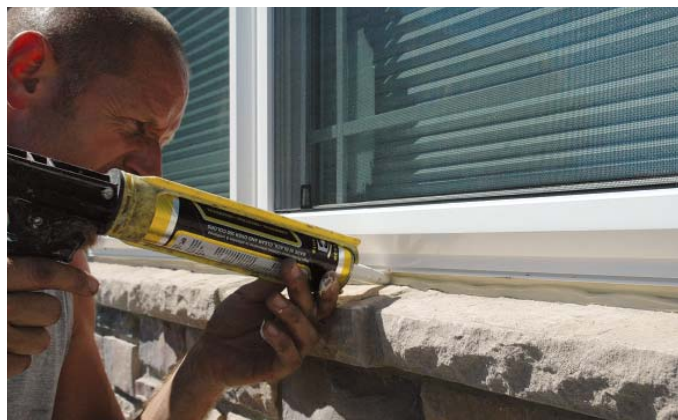
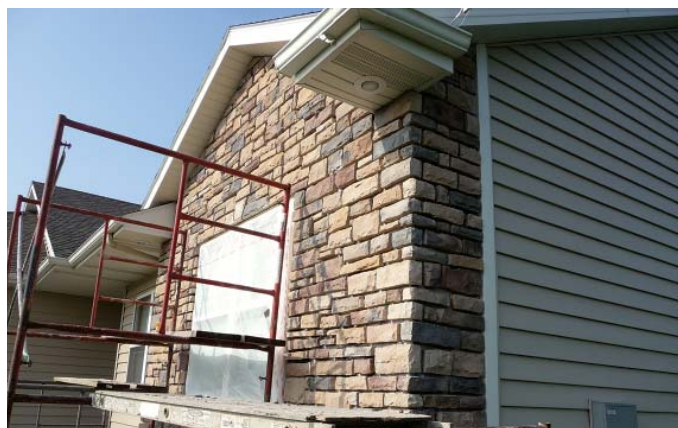
Figure 7. Backer rod inserted between the metal J-mold and the window frame (above) prevents the sealant used to fill the gap (above right) from adhering to the back of the joint, allowing it to remain flexible without pulling away from the sides. At right, the finished wall.

#900 Solar Seal adhesive sealant (800/654-1042, npcsealants.com), a solvent-based product that cures even when the mortar is still damp (Figure 7).
