Rescuing a Manufactured-Stone Wall

A properly flashed water-resistant drainage plane is essential when installing stone veneer over a wood-framed wall

by Mark Parlee

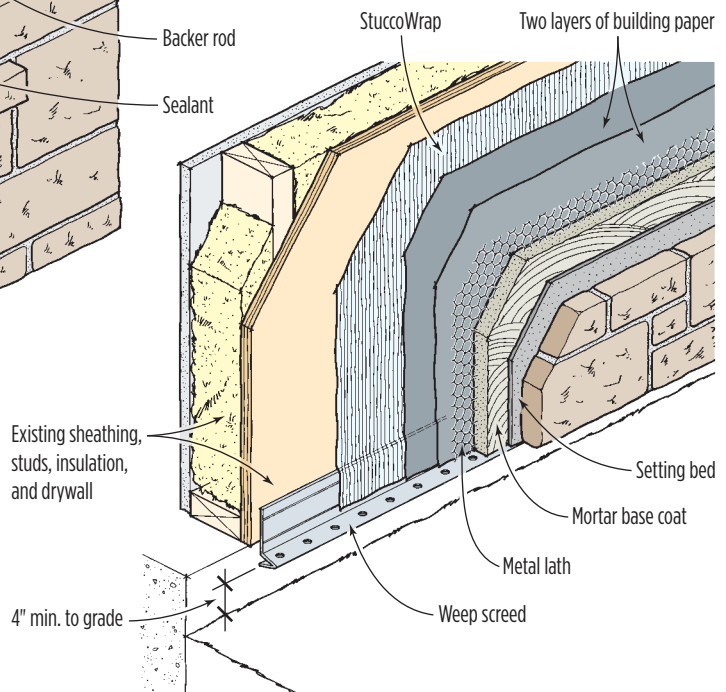
Wall Base

A double layer of building paper installed over StuccoWrap creates a drainage plane beneath the mortar base coat. Galvanized metal weep screeds at the top of the window and at the base of the wall allow water to drain out of the assembly.
